Case Studies

:: Conservation Hedgerow

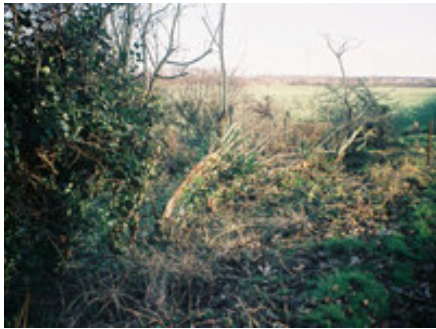
The hedge was dominated by ivy and was half rotten, past management had been laying (approx 40 years ago) subsequent flail trimming resulting in thick and entangled 'birds nests' at two heights.

- Removed ivy from base of hedge on both sides
- Face-up and cut into the hedge – about 80% material removed.
- Cut out and removed dead and decaying material (about 50% of balance).
- Laid and coppiced the remaining sound growth, leaving a few standards as features.
- Staked at about 1m centres and bound with willow and hazel available on site.
- Replanted gaps with hawthorn to provide variation.
- Waste material burned on site, site left in a tidy state.
- Re-inspected – particularly with regard to rabbit damage.
- Re-inspected to check growth of replacement plants.
