Case Studies

:: Conservation Hedgerow

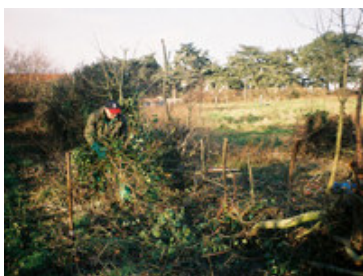
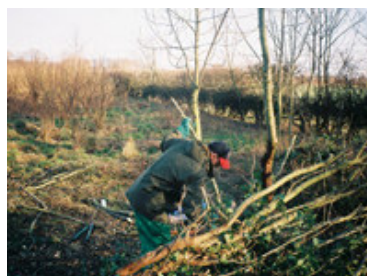
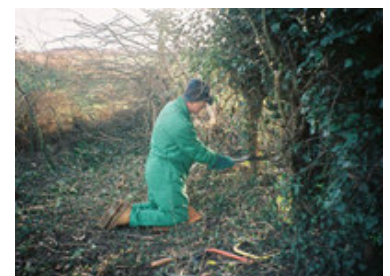
The hedge was dominated by ivy and was half rotten, past management had been laying (approx 40 years ago) subsequent flail trimming resulting in thick and entangled 'birds nests' at two heights.

- Removed ivy from base of hedge on both sides
- Face-up and cut into the hedge – about 80% material removed.
- Cut out and removed dead and decaying material (about 50% of balance).
- Laid and coppiced the remaining sound growth, leaving a few standards as features.
- Staked at about 1m centres and bound with willow and hazel available on site.
- Replanted gaps with hawthorn to provide variation.
- Waste material burned on site, site left in a tidy state.
- Re-inspected – particularly with regard to rabbit damage.
- Re-inspected to check growth of replacement plants.
